Richland Township  
S.E. Qtr. Sec. 9  
T-8 N; R-9 W  
Holmes County, Ohio

SURVEYED FOR: Bill Crichtfield

Basis of Bearing: Grid North, Ohio State Plane  
Coordinate System Ohio North Zone, NAD 83.

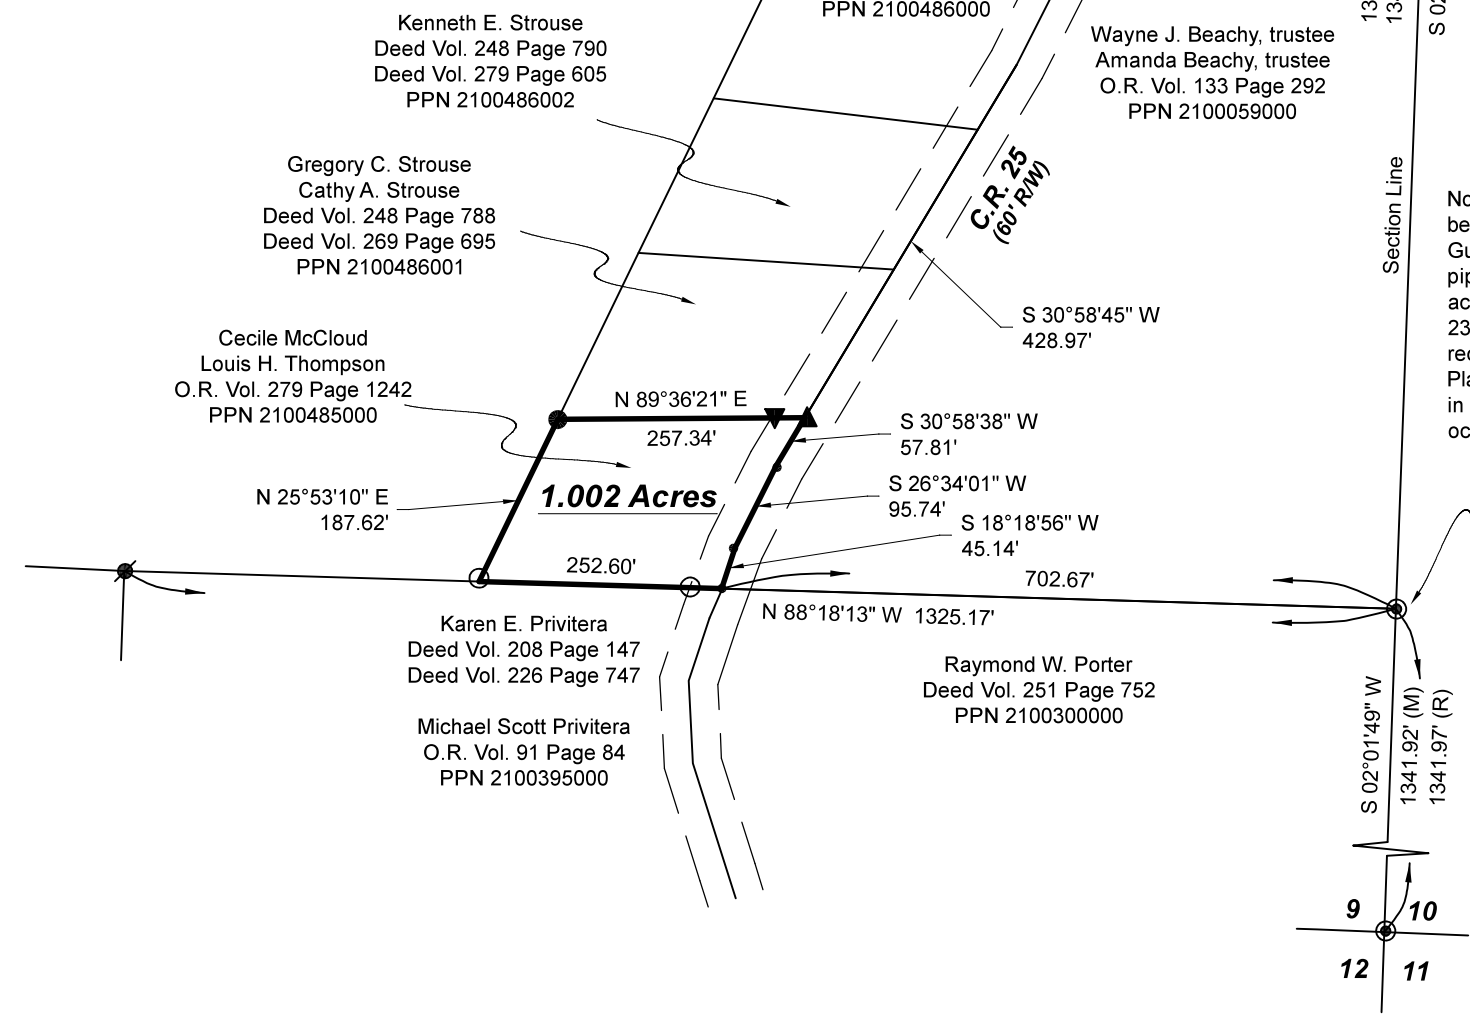
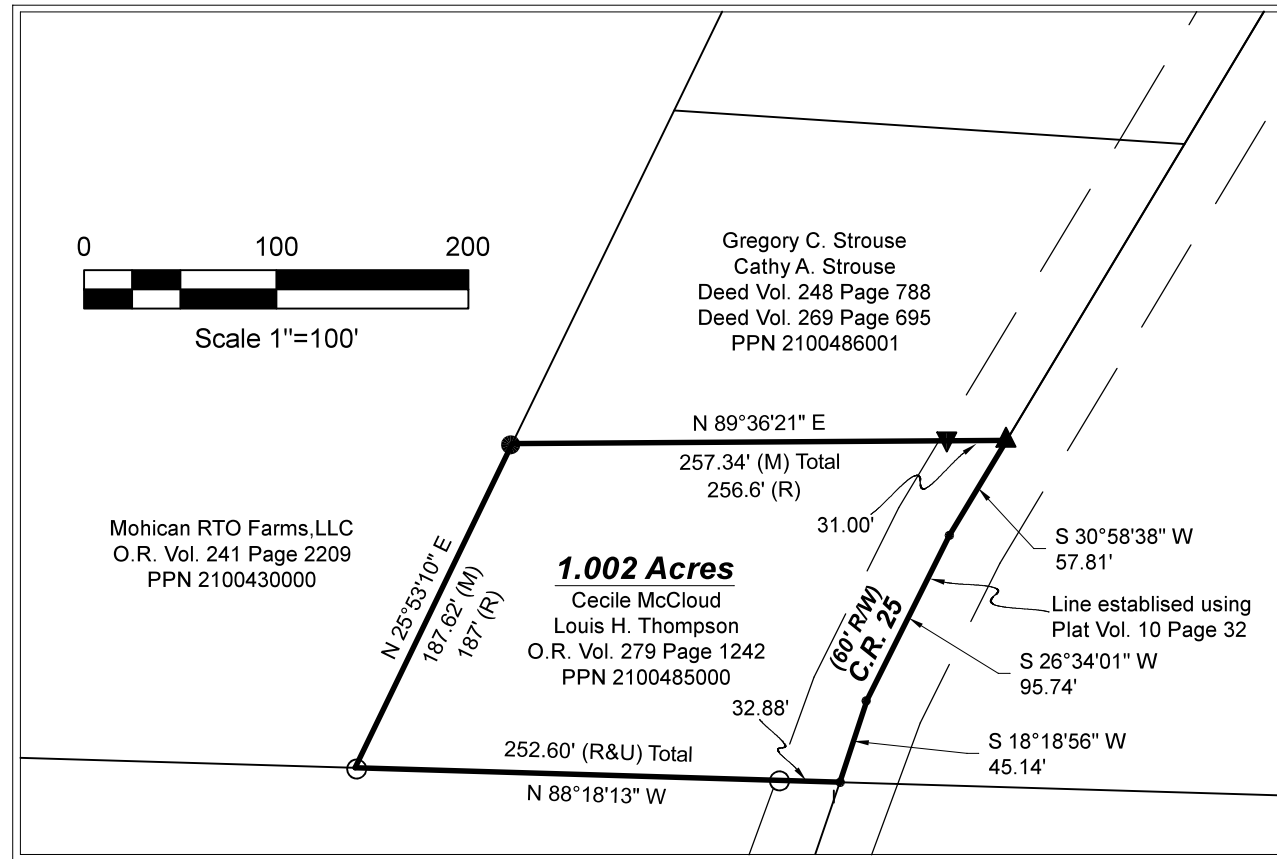
Note: The 1/2" pipe found at this corner is believed to be the original pipe set by James Gute in 1975 and is believed to be the same pipe noted in Plat Vol. 19 Page 1036 which according to mathematical calculations falls 23.07' south of the found pipe. I was unable to recover a pipe at the location shown on said Plat 19 Page 1036. I held the pipe as found in the field which also agrees with physical occupation.
