Village of Millersburg  
Part of  
Pleasant View Glass Plant Add. Block 11  
(Plat Vol. 1 Pages 357-362)  
Hardy Township  
1st Qtr. Lot 47  
T-9 N; R-7 W  
Holmes County, Ohio

SURVEYED FOR: Barb Snyder

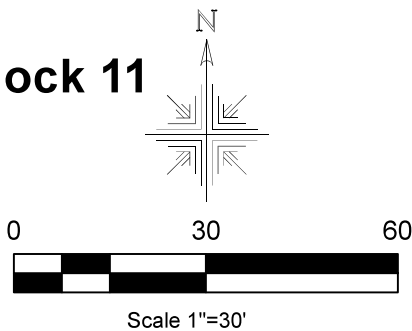
Basis of Bearing from Ohio State Plane  
Coordinate System, North Zone, NAD 83 (2011).  
Distances shown hereon are ground distances.  
To obtain grid distances multiply by a scale factor  
of 0.99994029

- ⊙ Pipe Found
- 5/8" Rebar Found
- ⊘ 5/8" Rebar Found Capped "Baker"
- ◆ 3/8" Rebar Found
- 5/8 inch Rebar Set Capped "Galbraith-8703"
- Point
