Village of Killbuck  
Bucy Subdivision  
Lot 3

Killbuck Township  
S.W. Qtr. Sec. 6  
T-8 N; R-7 W  
Holmes County, Ohio

SURVEYED FOR: Will Morehouse

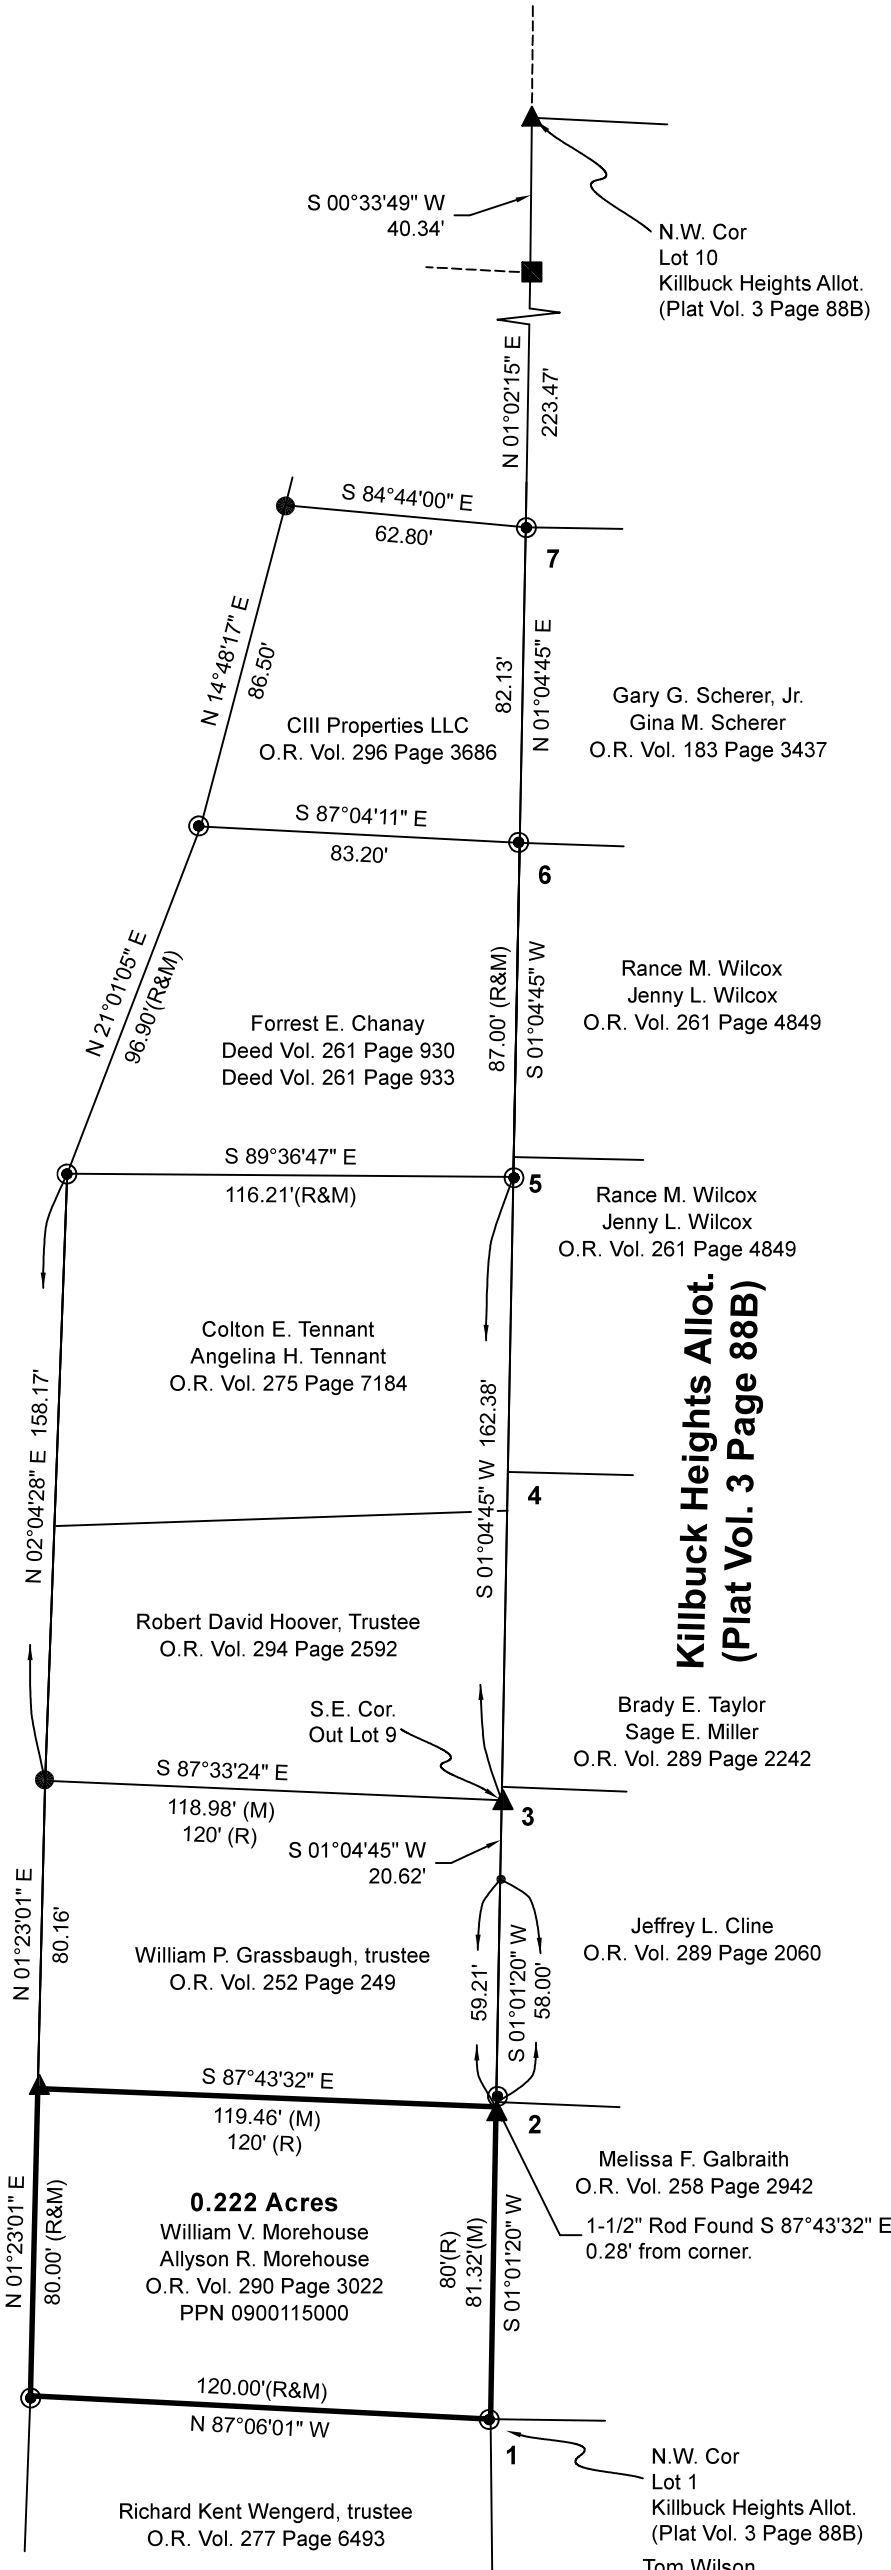
Bucy Drive (49.5')
