**Richland Township
S.E. Qtr. Section 25
T-8 N; R-9 W
Holmes County, Ohio**

SURVEYED FOR: David Blubaugh

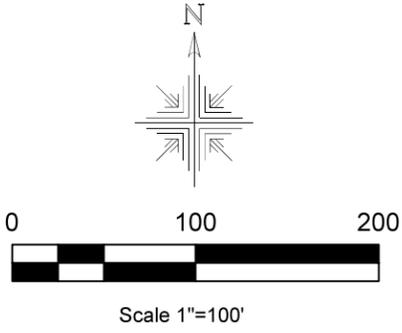
CURVE	RADIUS	ARC LENGTH	CHORD LENGTH	CHORD BEARING	DELTA ANGLE
C1	354.68'	180.12'	178.19'	S 09°02'23" W	29°05'49"
C2	354.68'	31.70'	31.69'	S 26°08'56" W	5°07'17"

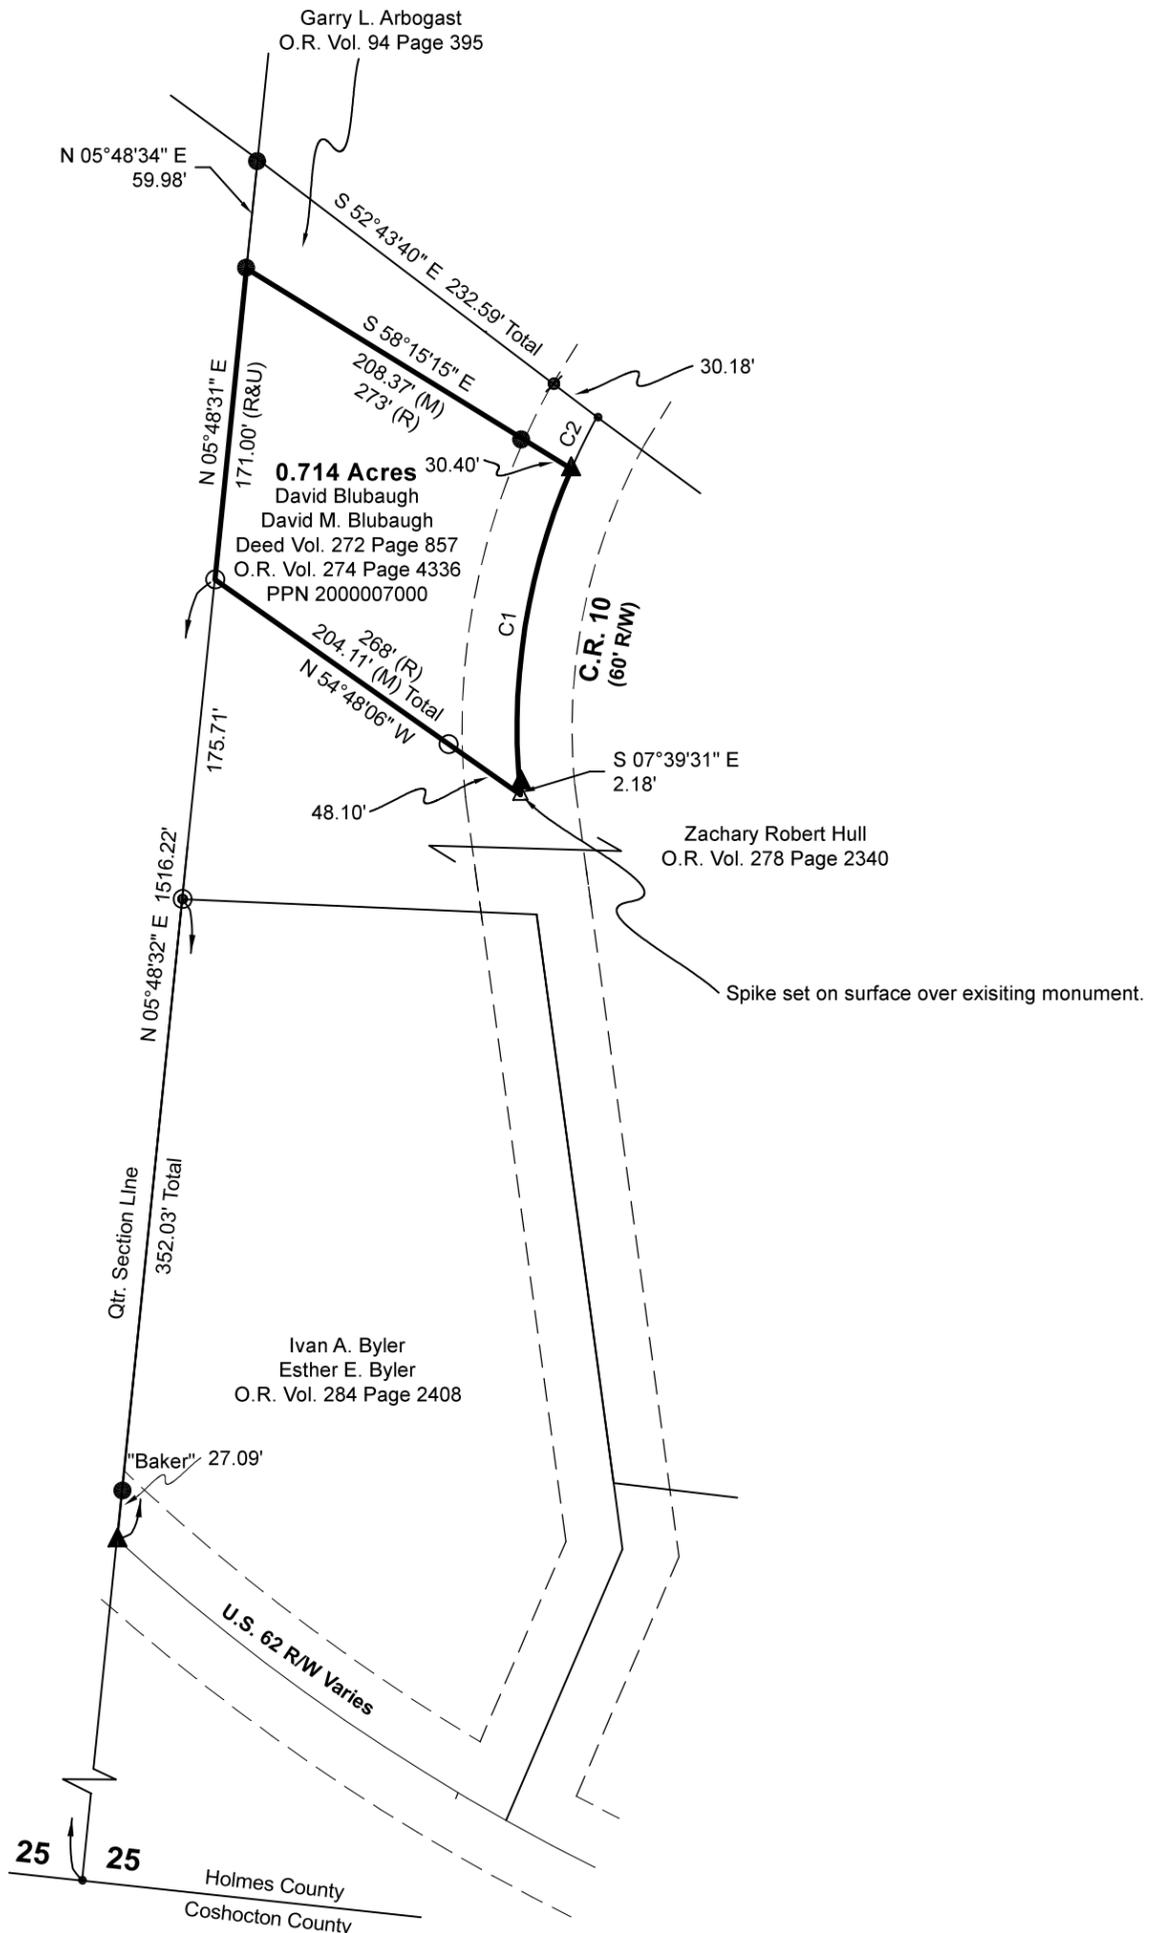
Basis of Bearing from Grid North, Ohio State Plane Coordinate System, North Zone, NAD 83(2011).

- ⊗ 5/8" Rebar Found Capped "Tracy & Mills"
- ▲ RR Spk. Found
- 5/8" Rebar Found unless noted
- ⊙ 3/4" Pipe Found
- 5/8" Capped Pin Set "Galbraith-8703"
- Point
